Manhole Inspection Summary

Manhole # S15SS1002MH

Insp Date: **11/30/06 3:38 PM**

Location Address: **CLYBURN AVE**

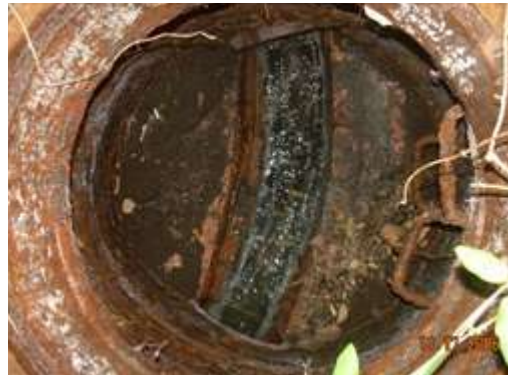
Top View

Bench debris. Corroded steps.

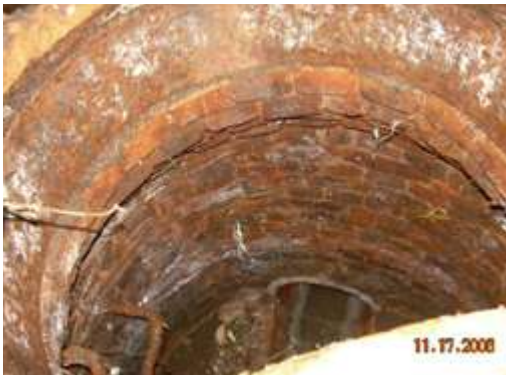
Defect

Condition: ☐ Sound ☐ Cracked ☒ **Root Intrusion** ☐ Loose Brick ☐ Deteriorated

Adjustment, Corbel, and Barrel root intrusion and infiltration.

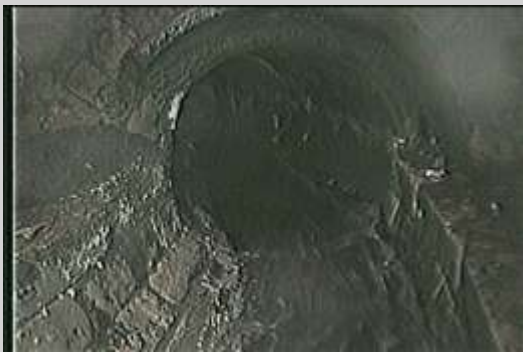
15 in. Circular Gravity Sewer Pipe Out @ 12 O'Clock

Infiltration: **Evidence** Pipe Seal Cond: **Cracked**

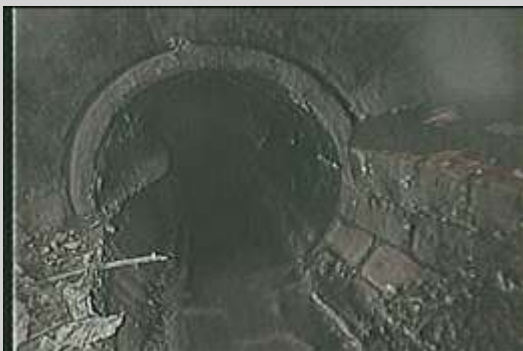
15 in. Circular Gravity Sewer Pipe In @ 7 O'Clock

Infiltration: **Evidence** Pipe Seal Cond: **Roots**
